## THE HUDDERSFIELD AND DISTRICT ARCHAEOLOGICAL SOCIETY

### THE MYTHOLMBRIDGE CORN MILL PROJECT

#### INTERIM REPORT

April 2015 to April 2017

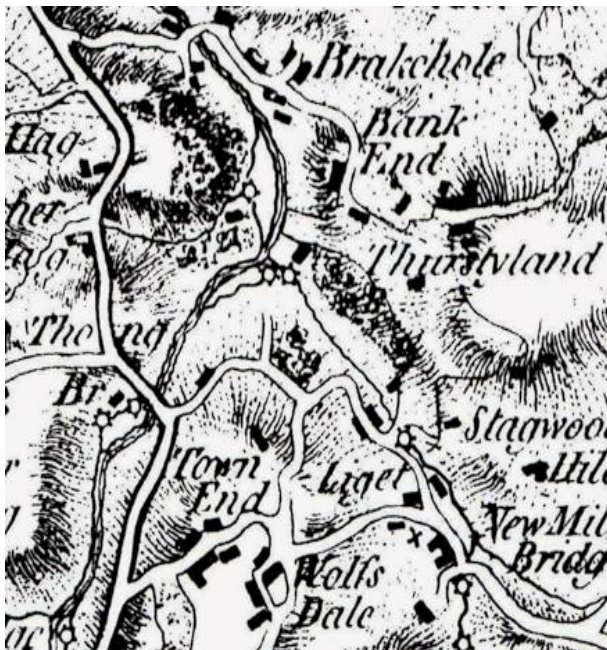
THOMAS JEFFERYS MAP, 1772

Subsequent research revealed evidence for a corn mill, which by 1890 had become no longer visible. An early indication of its existence is provided by Thomas Jeffery's map, "The County of York survey'd, 1772", which shows two mill symbols, at the confluence of New Mill Dyke with the River Holme.

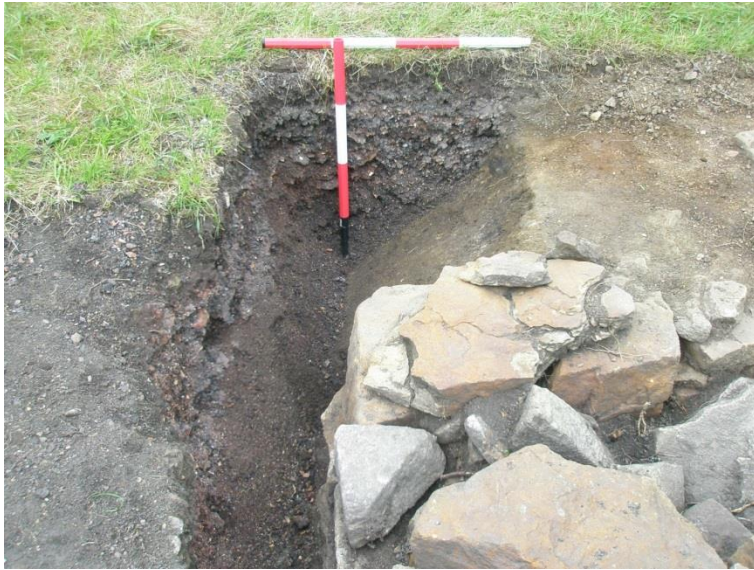
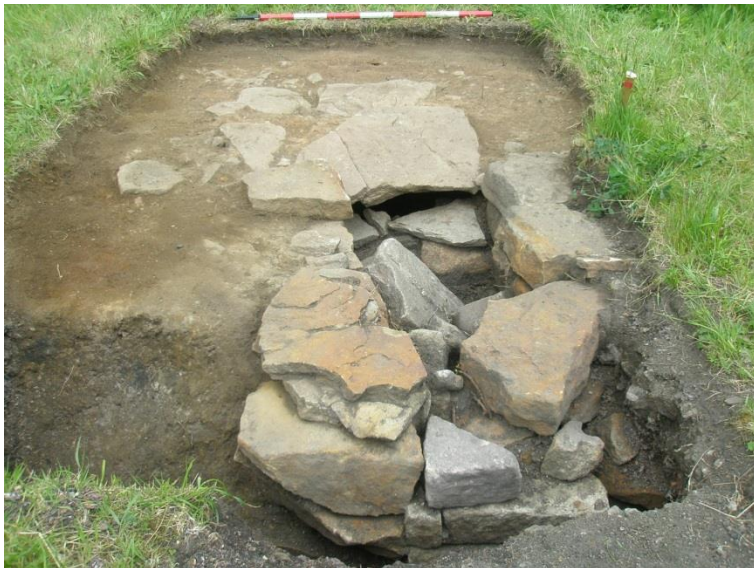
In May 2015, an exploratory trench/test pit was dug near the ridge first mentioned by the present owner, and shown by discolouration on a Google image. Its location was determined by taking bearings from field walls shown on the 1854 OS map. Immediately below a thin soil layer was a deposit of clinker over 1.0 metres deep. It was thought that this represented infill on the site of the mill pond, possibly from the boiler rooms of local industry in the late 19thC and early 20thC, and that following the demise of the corn mill the site had been used as a tip. A subsequent field walk identified stone near the surface nearer to the car park. At this point in time, only the 1854 map was available to show the position of the mill, and early measurements based on this seemed to indicate that the mill building was now beneath the car park adjacent to the field. A Survey Grid was established over the area identified on the 1854 OS map as the site of the mill and the adjacent northern end of the mill pond. The control point was the SW corner of the present Studio (formerly small warehouse and then garage), shown as an outbuilding to the farm in 1854, and now at the edge of the current car park. The step to this building also acted as the Temporary Bench Mark (TBM).

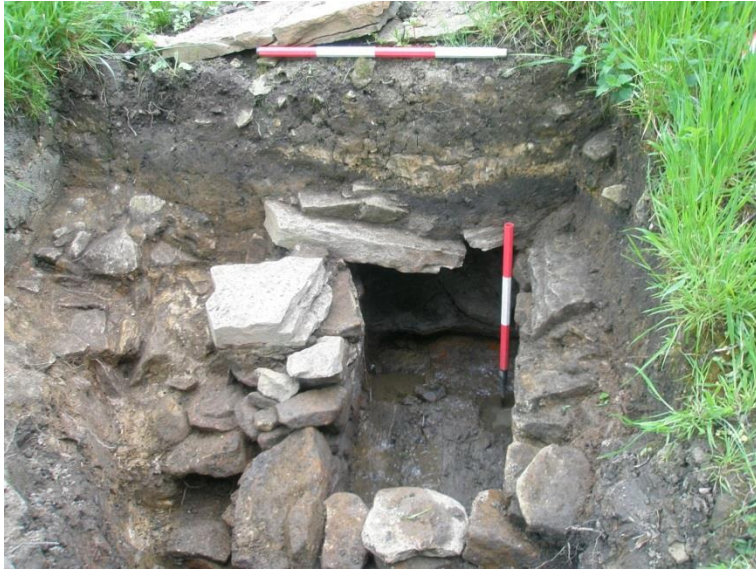
TRENCH 1, SONDAGE A

It was then decided to open a second test pit on the site of the exposed stone in the field. This subsequently became trench 1, and it revealed a culvert comprised of dry stone walls 0.6 m apart, to a depth of 1.45 m, with broken capstones, and a marked cut where thick deposits of clinker lay up against what was subsequently interpreted as the inner face and crest of a clay dam to the mill pond. Along the floor of the culvert was a relatively modern drainage pipe, which we interpreted as representing a relatively recent adaptation of an older structure to provide a field drain. As the trench was widened, the area to the NE was found to be considerably disturbed with various overlying deposits of fill. The owner believed this area to have been near where a utilities trench had been dug and a subsequent resistivity survey showed a diagonal shadow of lower resistance crossing over that area. It was also decided to follow the line of the culvert down slope towards New Mill Dyke. Here a sondage was dug to reveal the lower reaches of the culvert. The foundations were shown to be built onto the bedrock, with a width of 0.6m and sidewalls 0.8m in depth. Once more the capstones were found to be cracked. A second sondage revealed the absence of a cut between

the culvert walls and the clay dam, suggesting that the culvert had been built first and the dam wall subsequently built up on either side of it.

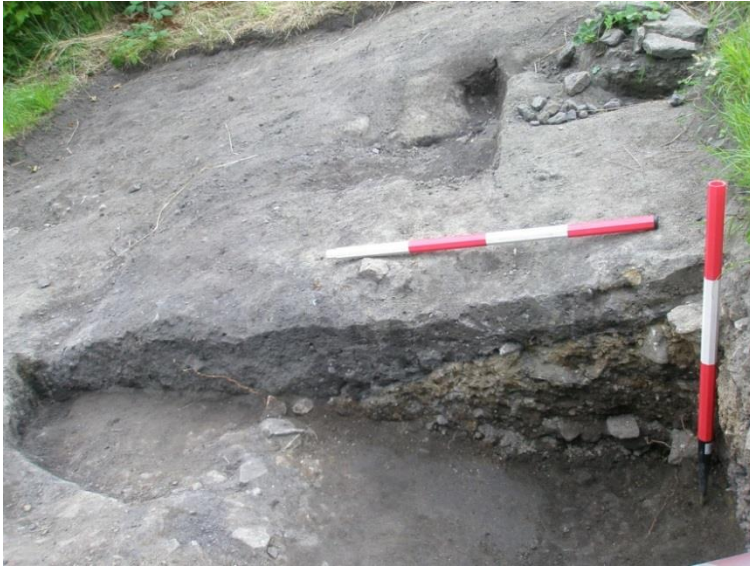
TRENCH 2

Trench 2 was opened immediately to the NW of the upper reaches of Trench 1, in the hope of identifying the dam wall on that side of the culvert, and the point at which it might turn inland away from New Mill Dyke to run behind the mill as shown on the 1854 OS map. However, it became clear that the area in close proximity to the culvert had been heavily disturbed resulting in overlapping layers of fill. This was found to coincide with the band of low resistivity, previously mentioned, which is shown to cut diagonally across the Survey Grid. This has already been interpreted as excavations relating to a utilities trench dug in the 1980's. In an attempt to relocate the clay dam, a sondage was excavated at the northern corner of Trench 2. This exposed a layer of undisturbed clay 1.42 m deep, resting on a block of dressed stone. Its relative position and height suggested that this could be a continuation of the dam wall at/near the point where it turned to separate the mill pond from the mill building.

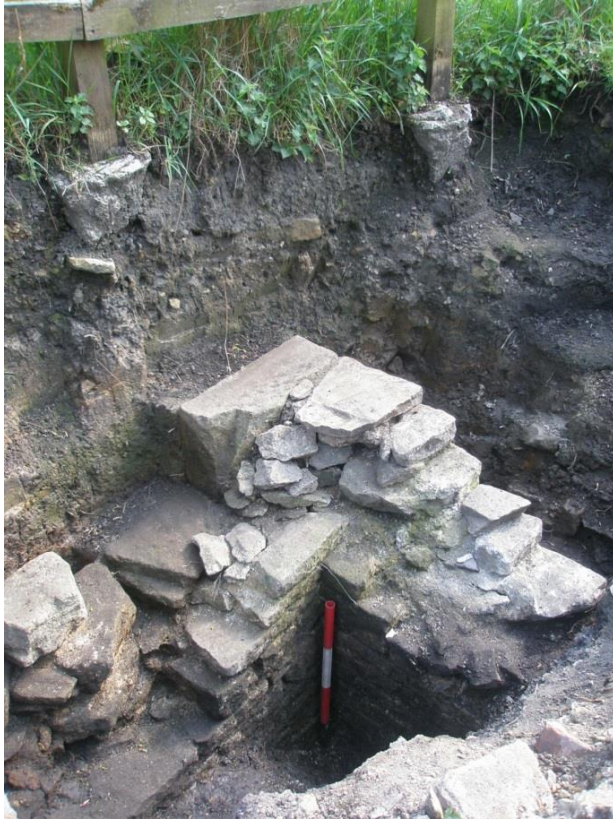
#### TRENCH 3, SW CORNER

After digging down through a layer of grey-brown soil, then light-grey clay with stone inclusions and finally black cinder to a depth of 0.98 m, the top of a dressed stone wall appeared. Further excavation revealed a section of back wall and a small section of sidewall extending under the car park. From the evidence provided, this was interpreted as the SE corner of the partially demolished mill. The section of sidewall lay beneath a jumbled mix of lime mortar and dressed stones. Widening of the trench to expose the back wall and corner involved cutting into a previously hidden, substantial layer of orange-white clay, but with a pronounced cut at the NE end facing the field, separating the clay from clinker. Any initial reaction that the clay was natural and cut into to build the foundations was contradicted by the subsequent exposure of a low lying extension of this clinker to the SW beneath the clay. The wall exposed is comprised of outer facings of finely dressed stone, with a stone rubble core bonded with a lime mix. However, at its north eastern end the stonework from which water seeped was stained a dark red-brown. This was seen as possibly indicative that a water supply to the mill was in close proximity. Ochre staining is a characteristic of the New Mill Dyke when old mines are flooded upstream. Traces of walling possibly extending under the field were also found. These consisted of more weathered stone which was also red-brown in hue and poorly bonded with the main back wall. No evidence to date this stonework was found.

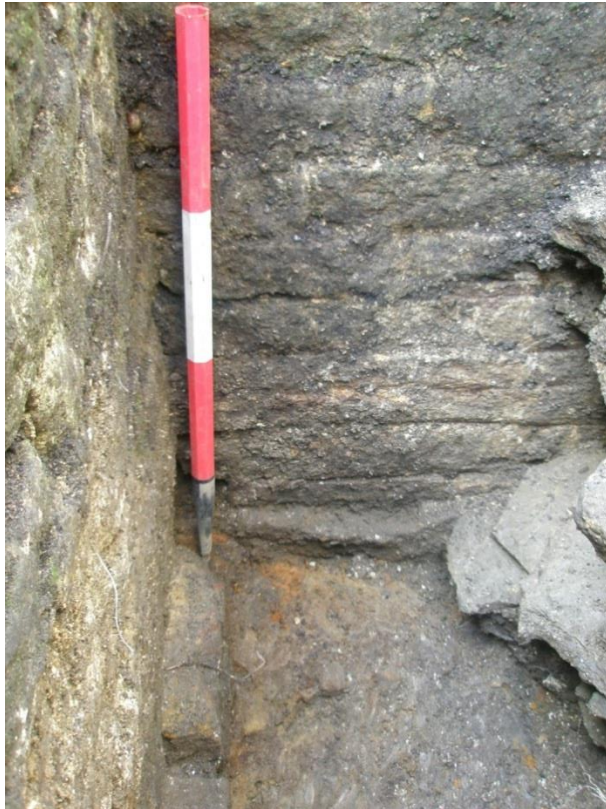
#### TRENCH 3, INNER WALLS SW CORNER

Having exposed this corner of the building, it was decided to excavate within the walls, and reveal the height of the remaining section of wall and its floor. Large blocks of dressed stone intermixed with clinker were removed, with the additional aid of shoring and props. At a depth of 2.85 m at the SW end and 2.97 m at the NE end of this trench, less well dressed foundations stones were located, and a surface of compacted stones sloping down eastwards from 2.94 m to 3.17 m below the string line. This was overlain by a thin deposit of dark red-brown silt on top of which lay broken flagstones. Having recorded this section of the building it was then decided to extend the NE end of the trench and to explore the outer wall in the SW corner. Both areas were to prove revealing.

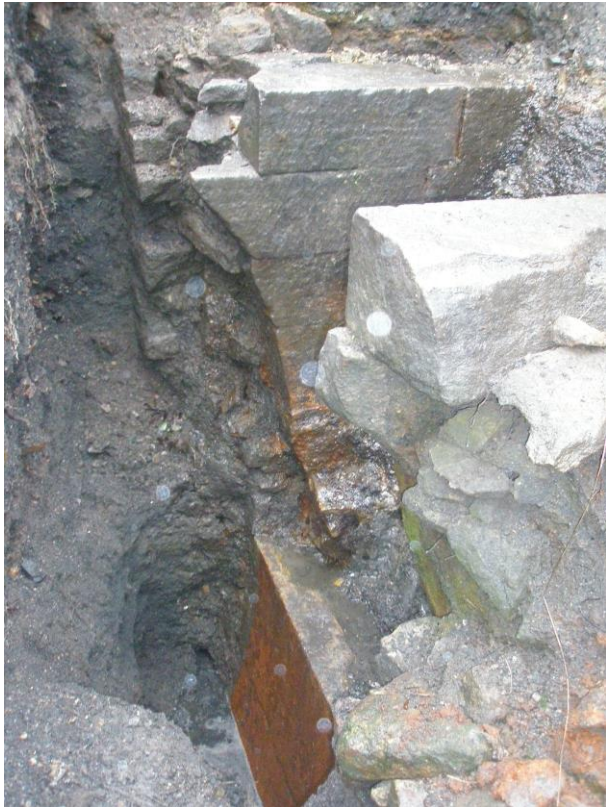
#### TRENCH 3, NE END

By cutting into the wall of clinker at the NE end, two parallel walls of dressed ashlar were exposed 1.0 m apart extending SE towards the field. Between these walls, there was a hard compressed layer of grey black cinder with inclusions consisting of fragments of coal, brick, stone and grit over a metre in depth, under which lay a band of white clay 14 cm thick and a lower band of grey clay 46cm thick resting on a stone sill. Water continues to ooze through the cinder. To either side of the ashlar the stone walls of the mill were stained dark brown. Above these deposits, below the fence line and field, was a layer of rubble then soil with a combined depth of over 1.10 m. The lip to this feature was further exposed by excavating another 1.28 m down, again with the aid of shoring and props. The lip was found to be made from large blocks of finely dressed stone with a noticeable curvature before levelling off some 40cm in from the top of the lip. Also the parallel stone walls had been cut away to leave two opposing arches. The feature has been interpreted as representing the wheel well and water channel to feed the wheel. The arches are thought to be where the axel and machinery were originally installed. Since the curve levels off some 1.28 m below the lip, it has been construed that the wheel itself had a diameter of over 2.40 m (9 ft.), and was of the mid-shot variety.

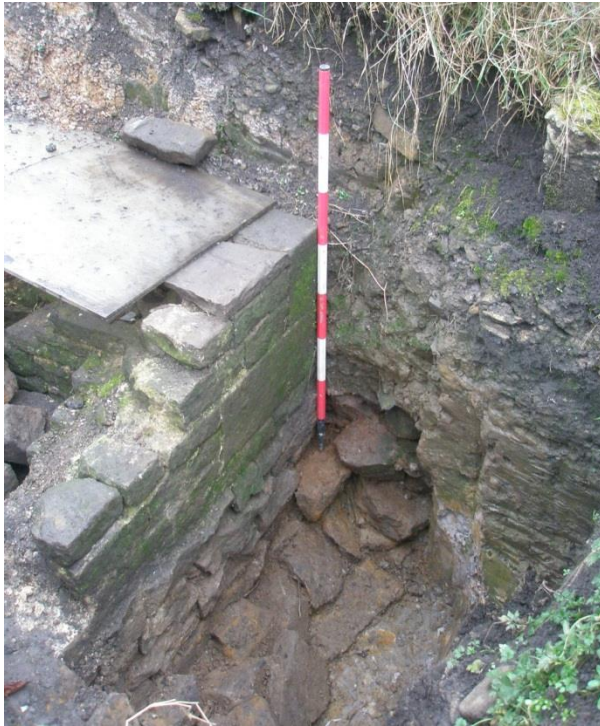
### TRENCH 3, OUTER WALL

At the SW end of the trench, further excavation involved cutting down into a thick layer of clay and removing very large blocks of stone. This revealed an outer wall which varied in composition. For 80 cm below the top of the corner stone, it consists of finely dressed layers of stone. For another 50 cm below this the stone work is more irregular and more crudely dressed. The final (as yet) 80 cm consists of coarse blocks of stone. In all, the outer wall extends downwards some 2.10 m and at its current lowest point is 3.05 m below the string line. This is not dissimilar to the depth reached internally within the SE corner of the building, but is noticeably different from the depth of the wheel well below the lip, which is some 4.0 m below the string line. It had also been hoped that by reaching the foundations of the building, dating evidence might be found. Unfortunately no such evidence was found in this trench. It was also hoped that the building standing in 1880 might have been built in or near older foundations. Though the nature of the stone work changes with depth this is not necessarily evidence of older foundations. That said the traces of red-brown stonework butting on to the back wall, and at the side of the water channel to the wheel well could well be remaining fragments of an older structure.

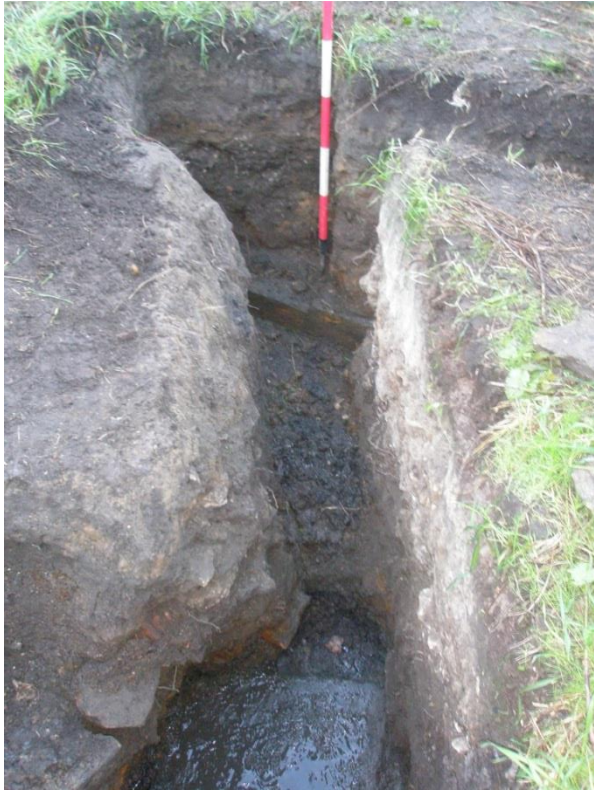
TRENCH 4

Trench 4 started as a test pit to locate any extension to the water channel into the field, and to determine how the water was transferred from the mill pond. An extension was found approximately 1.0 m below the surface of the field. However, the sides of the channel were found to be diverging, and over a distance of 1.5 m had widened from 1.0 m apart near the fence boundary at T3 to 1.6 m apart further into the field in T4. At the NE end of the trench, the dressed stone was found to curve in a NW direction in a line similar to that shown for the edge of the mill pond running behind the mill on the 1854 map. At the SW end, the side of the mill pond was shown to approach the rear of the mill at an angle before straightening to follow the line of the water channel in T3. Beneath a thin soil cover, most of the overlay consisted of rubble with large dressed stone inclusions intermixed with some metal objects (inconclusive), glass fragments, and part of a pipe stem. Under this was a thin layer of red-brown clay with grit inclusions, a pot sherd and clumps of felt or hair. The widening was considered as possibly to 'funnel' water from the mill pond into the channel. In addition, level readings on the top stones showed an O.D. height of 120.33 m and 120.57 m, whereas the level taken on the crest of the clay dam identified in Trench 1, had a height of 121.56 m, and the bottom of the culvert a height of c.120.02 m. This would have enabled the culvert identified in Trench 1 to act as an overflow channel. In Trench 3, the overflow lip for the wheel was a further 1.63 m below the top stone of the channel, at a height of 118.81 m. At some point in the field this would require a sluice gate to control the flow of water from the mill pond passing over the dam and descending into the water channel to feed the wheel.
