## Excavations at Mytholmbridge Lower Mill

The Holme Valley Camping & Caravan Park is located on the site of Mytholmbridge Lower Mill, where a mill has existed since the 18<sup>th</sup> century. Over the succeeding centuries it experienced much change and expansion before being demolished in 1975.

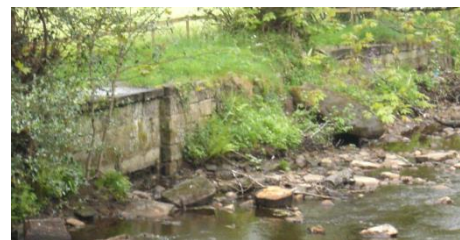
Two sluices are visible from the footbridge across the river. On an 18<sup>th</sup> century plan these are shown feeding water to the mill by means of goits (or watercourses) crossing the present camping field. HDAS excavated the sluices and goits from 2017-18.

Each sluice was double-gated and constructed in dressed stone. The sluice further from the bridge was built first. Little now remains of its workings, with wooden and metal components severely damaged or eroded over time. Evidence was found of a gate, level with the top of the water inlet, which may have been operated by a rope or chain.

The second sluice revealed remnants of vertical and horizontal beams, together with provision for metal plates and ratchets. The river itself has accumulated considerable amounts of debris and silt over the years, particularly in flood episodes: its bed would have been considerably lower than it is now.
